Arborist Report for On The Park

Leslie Street, Parts of Lot 1, Concession 3, East of Yonge Street

City of Toronto, Ontario

December 5, 2014

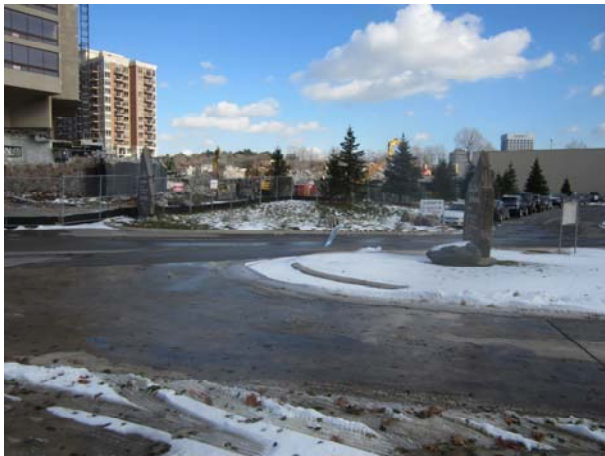
Figure 1. View looking east from the south west end of the proposed development boundary adjacent to car dealership parking lot entrance.

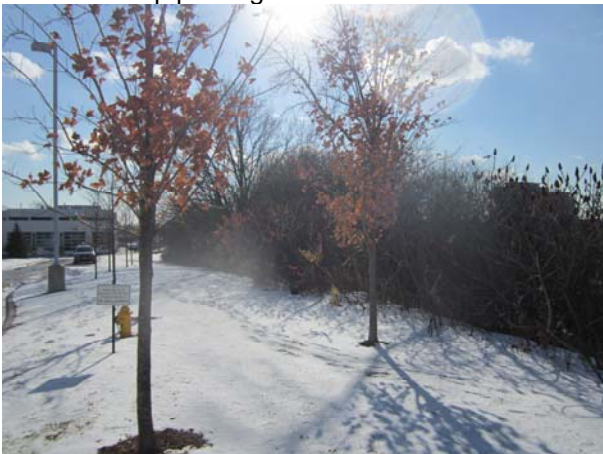
Figure 2. View looking south along access road towards vehicle dealership adjacent to Leslie Street.

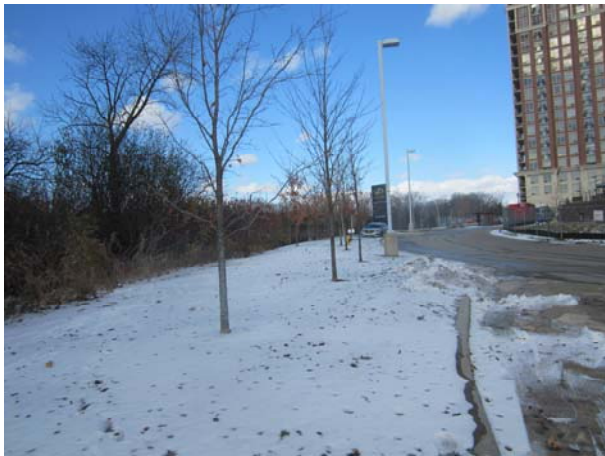
Figure 3. View looking north along access road adjacent to Leslie Street.
